# Manhole Inspection Summary

Manhole # S09WW1013MH

Insp Date: **10/18/06 11:11 AM**

**Location** Address: **5601 MERVILLE AVE**

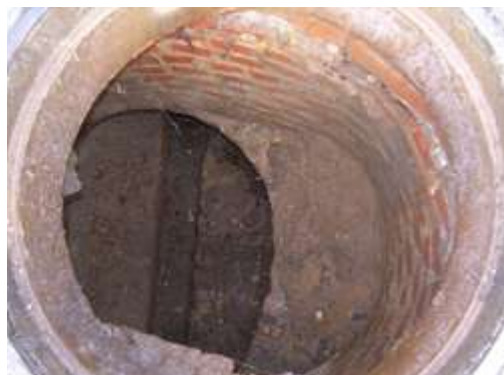
Top View

Evidence of surcharge - Bench debris.  
Channel debris.

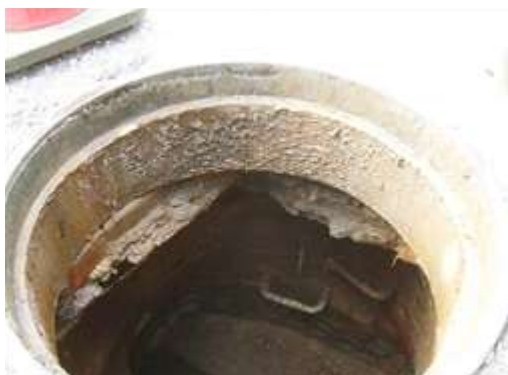
Defect

Frame leaks. Adjustment deterioration  
and infiltration. Barrel infiltration.

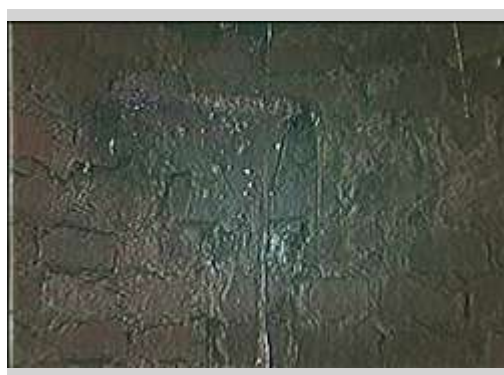
Defect

Corbel deterioration, root intrusion and  
infiltration.

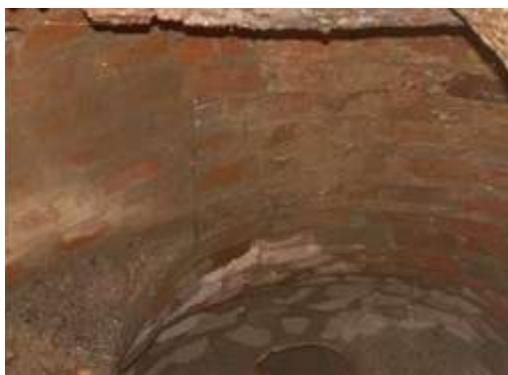
Defect

Corbel and Barrel infiltration.

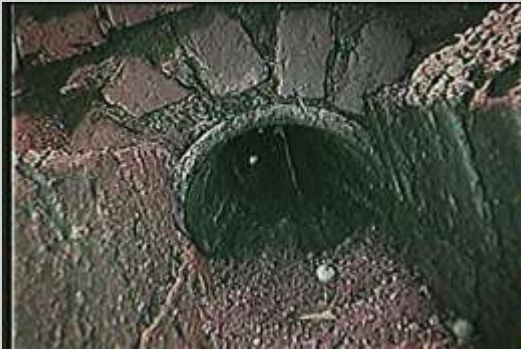
### 8 in. Circular Gravity Sewer Pipe Out @ 12 O'Clock

Barrel deterioration and infiltration. Channel deterioration and Channel debris.

Deposits: ☐ None ☒ **Mud** ☐ Sludge ☐ Debris ☐ Grease

Silt Depth: **2** (in.) Deposits Extent: **Light**

Infiltration: **Evidence** Pipe Seal Cond: **Unknown**

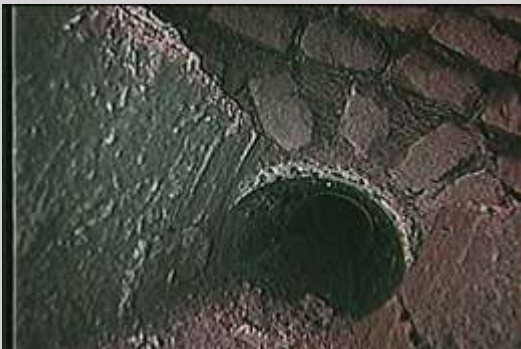
### 8 in. Circular Gravity Sewer Pipe In @ 6 O'Clock

Deposits: ☐ None ☒ **Mud** ☐ Sludge ☐ Debris ☐ Grease

Silt Depth: **2** (in.) Deposits Extent: **Light**

Infiltration: **Evidence** Pipe Seal Cond: **Unknown**
